Archaeological Data Recovery at the Lockville Historic Complex

Site 31CH690

**Chatham and Lee Counties, North Carolina
TIP No. R-2500
State Project No. 6.409006T**

**North Carolina Department of Transportation
Planning and Environmental Branch
Raleigh, North Carolina
May 1998**

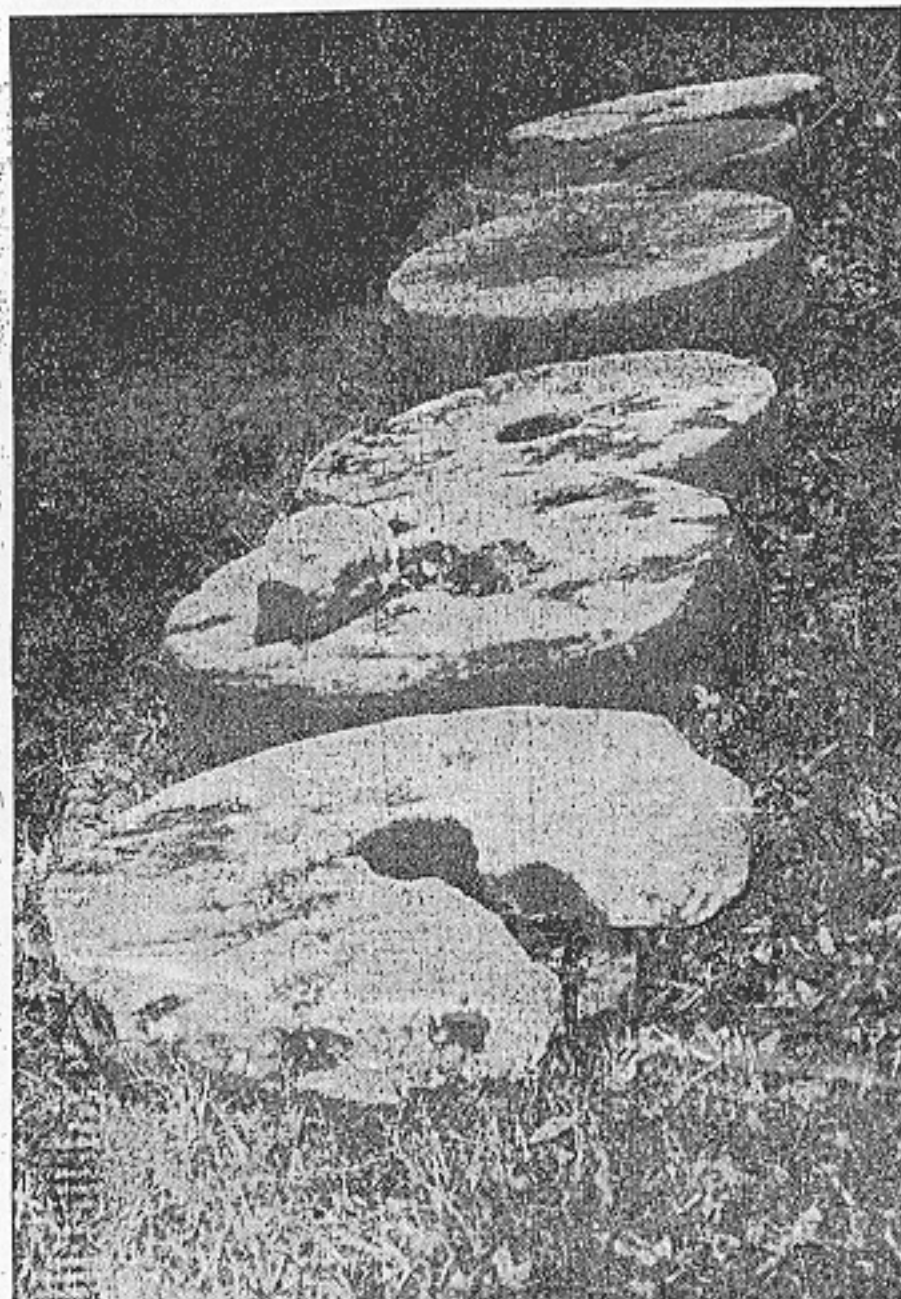
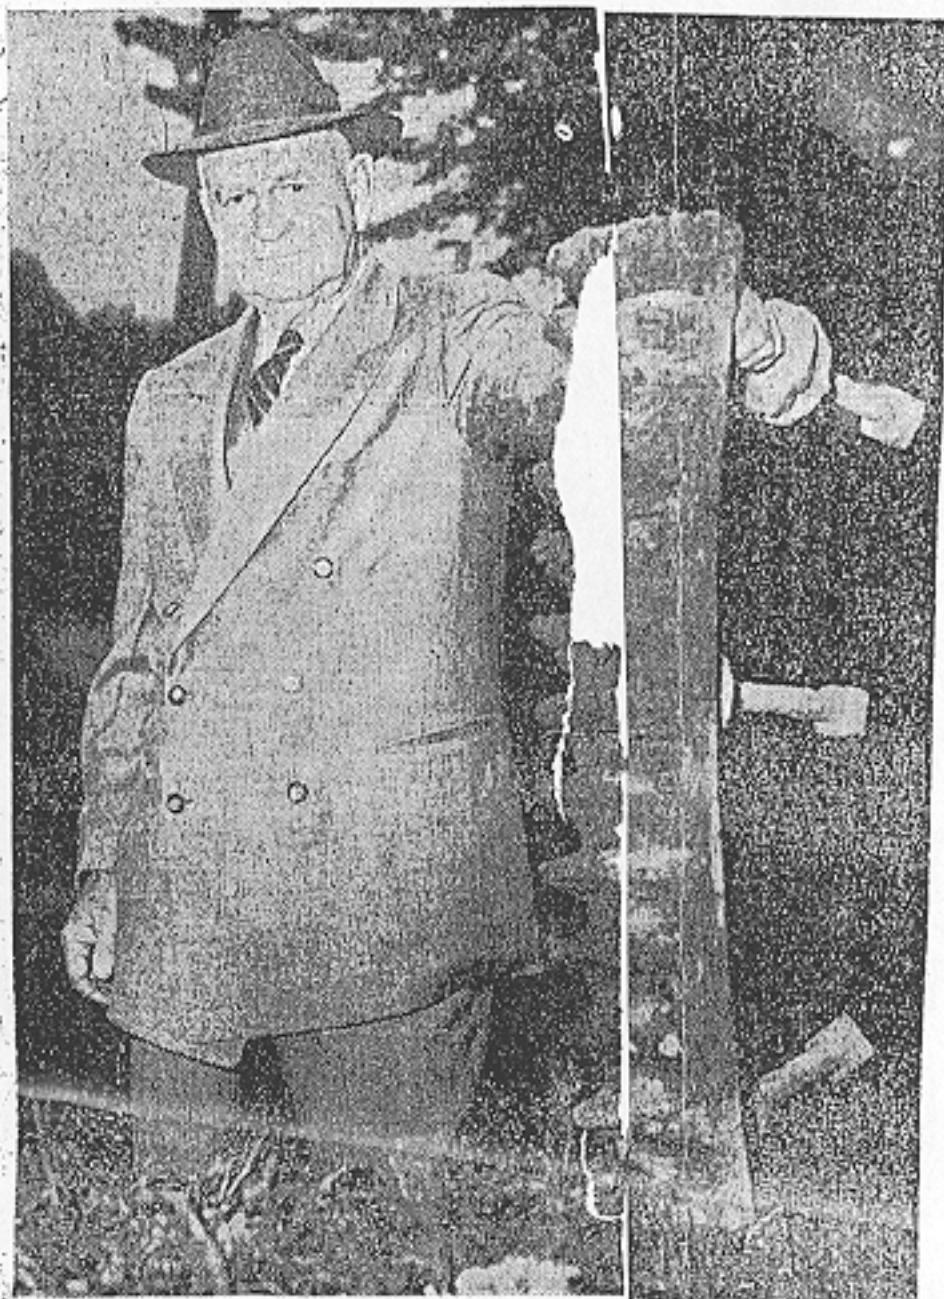
SIX MILLSTONES recently taken from the site of the old Ramsey's Mill in order that they might be preserved for historical value are pictured at left. At right a segment of the gear wheel which was a part of the machinery that transferred power to millstones in the Ramsey mill is displayed by Paul Barringer.

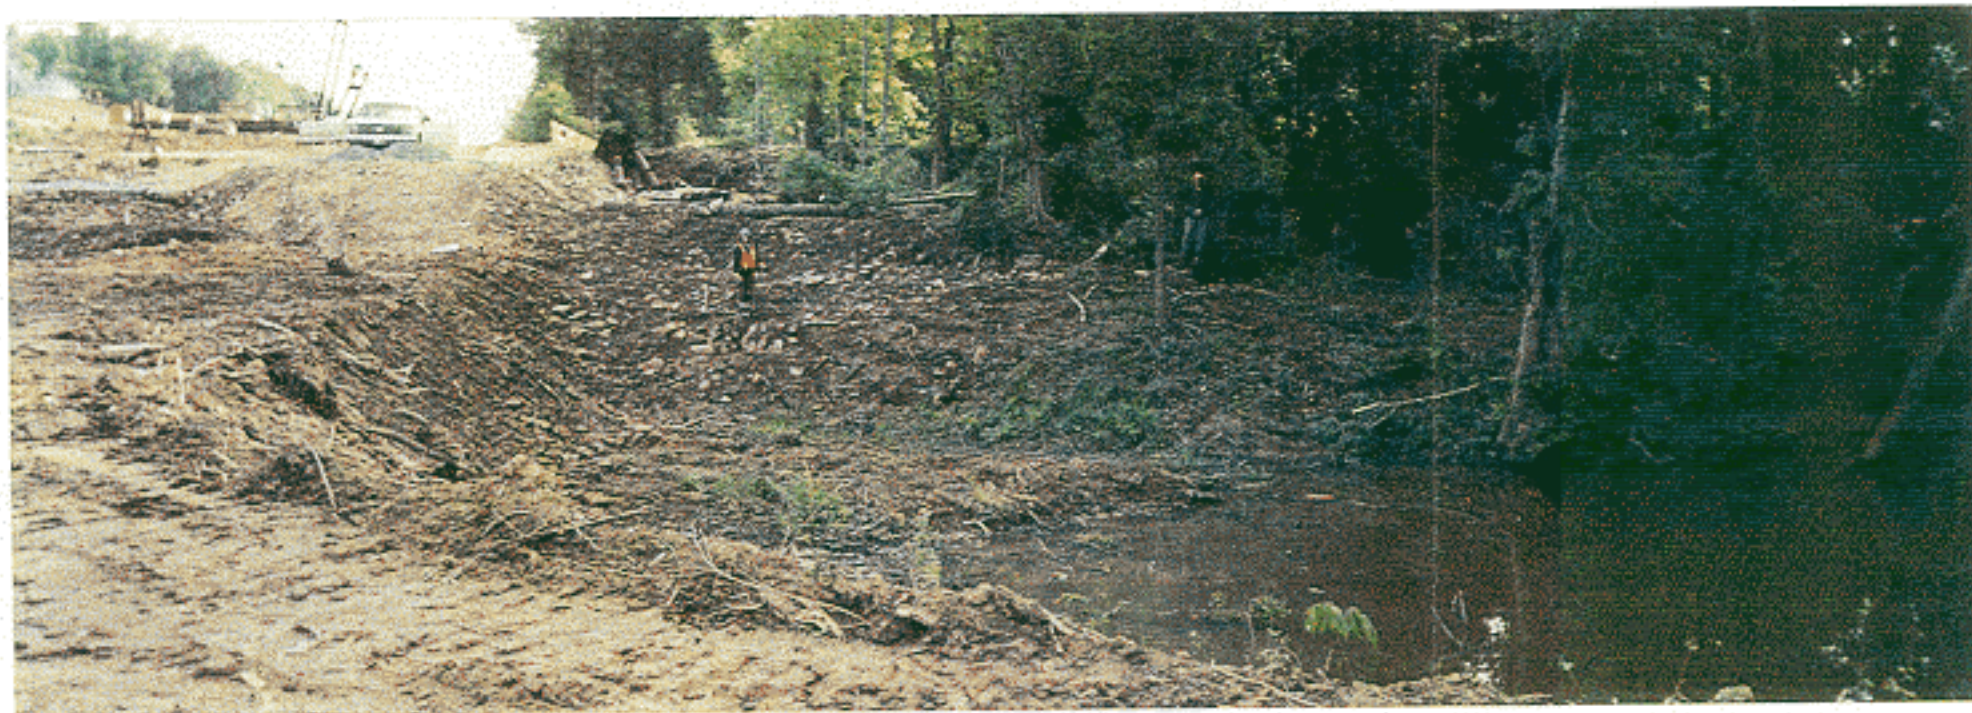
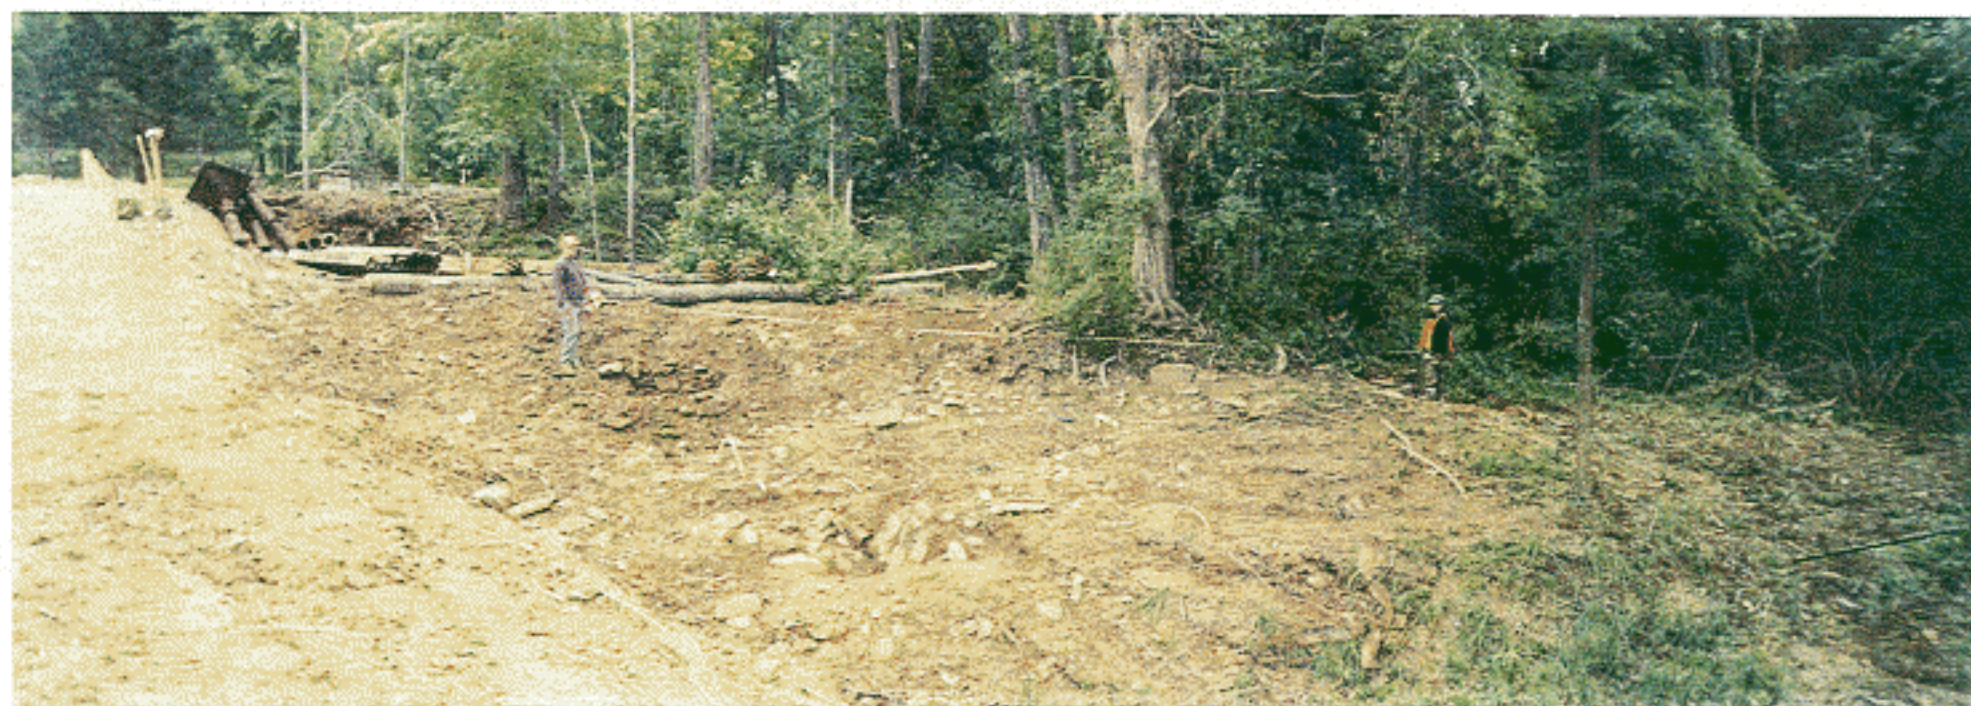
Figure 16. Photographs of Ramsey's Mill Area of Site, Including Wall Ruins and Terracing. (a) Spill pond in foreground; archaeologist on left is standing on lower foundation wall; archaeologist on right is on corner of upper foundation wall; (b) both archaeologists standing in line with upper (south) foundation wall.

The slope where the mill foundation walls are located is stepped with the upper bench formed by the north foundation wall of the mill and the lower step formed by the southern foundation wall (Figure 16). Circular metal bands were found sticking out of the eroded lower step of the ruin (Figure 17c). These were bandings around the stone mill wheels which were previously removed. A 14-foot long section of the north wall was exposed at the structure's northeast corner (Figures 17 a and b). The excavation in this area extended to a depth of 3 feet. The wall is approximately two feet thick. Stones used in the construction included roughly cut blocks and irregular shapes. The stones are tightly joined and mortared. A second exposure, 4-foot long, was made along the western side of this wall (Figure 16 and 17a).

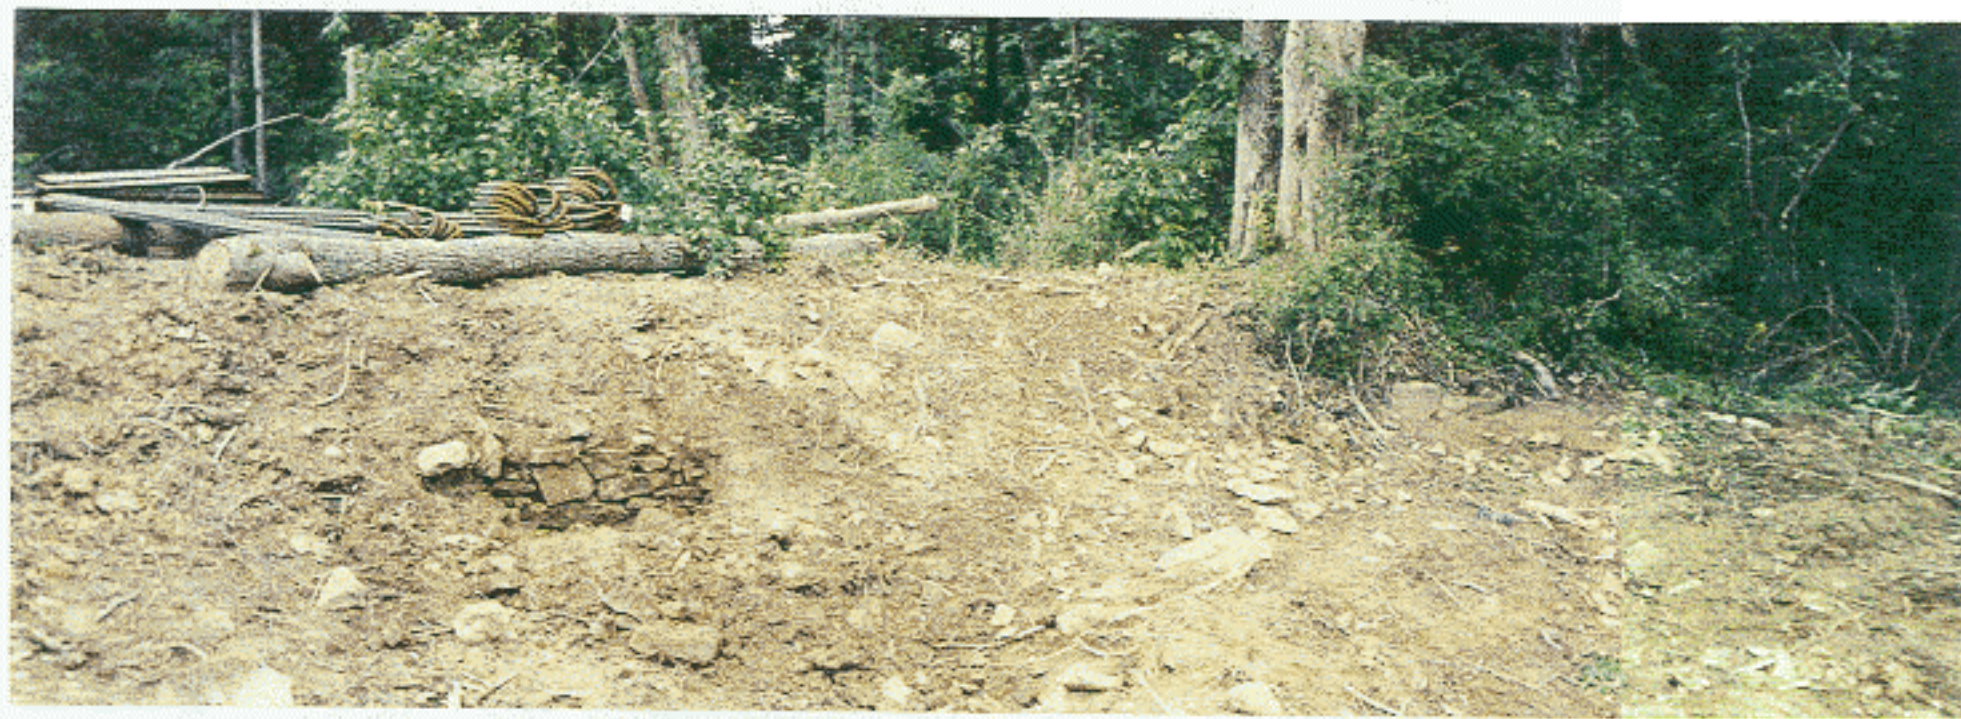
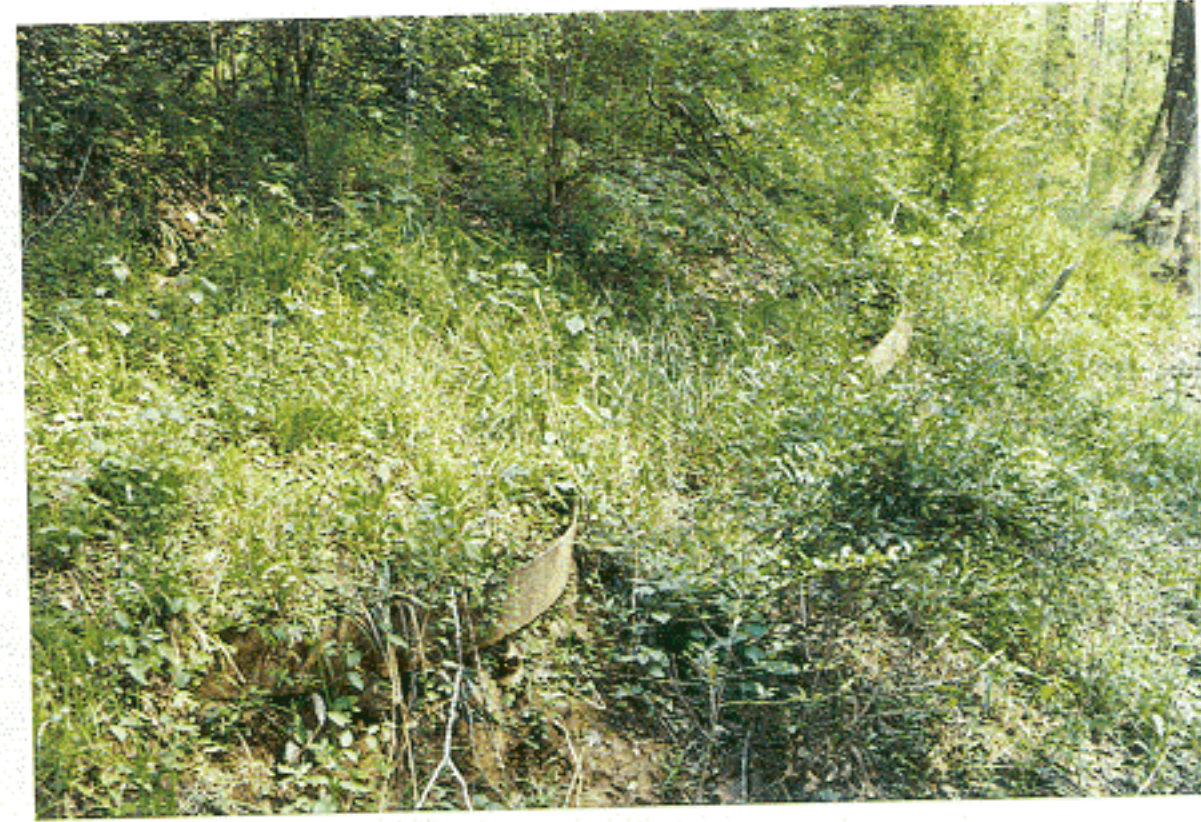
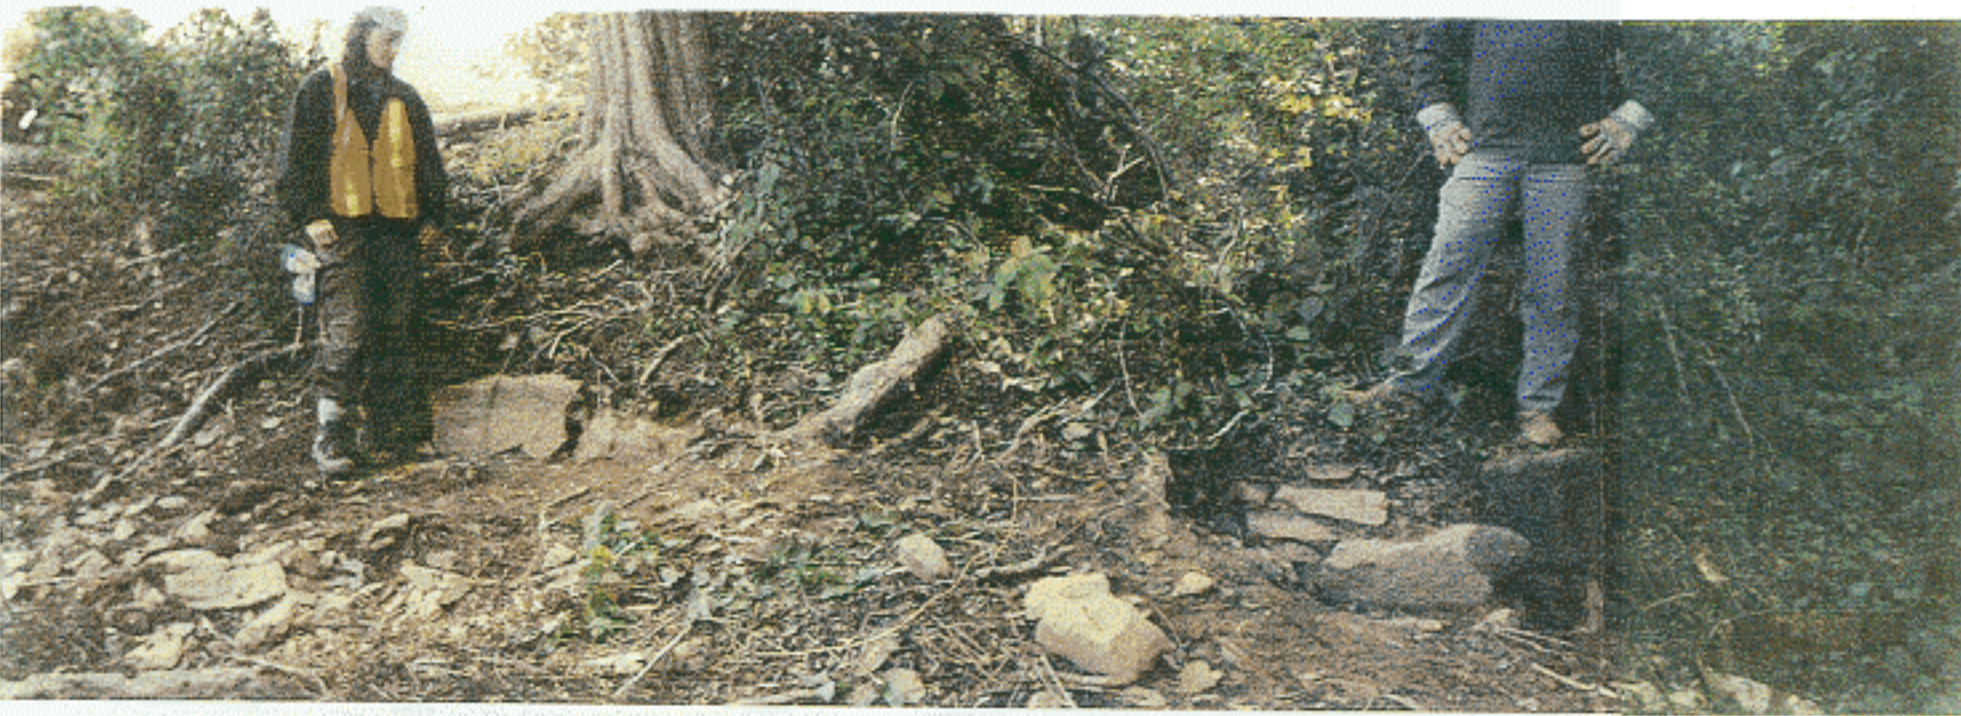
Figure 17. Close-up Photographs of Ramsey's Mill Area of Site Showing Archaeological Features. (a) Upper foundation wall, trees mark corner; (b) close-up of corner foundation stones; (c) iron bands from mill works, probably retaining bands around mill stones.

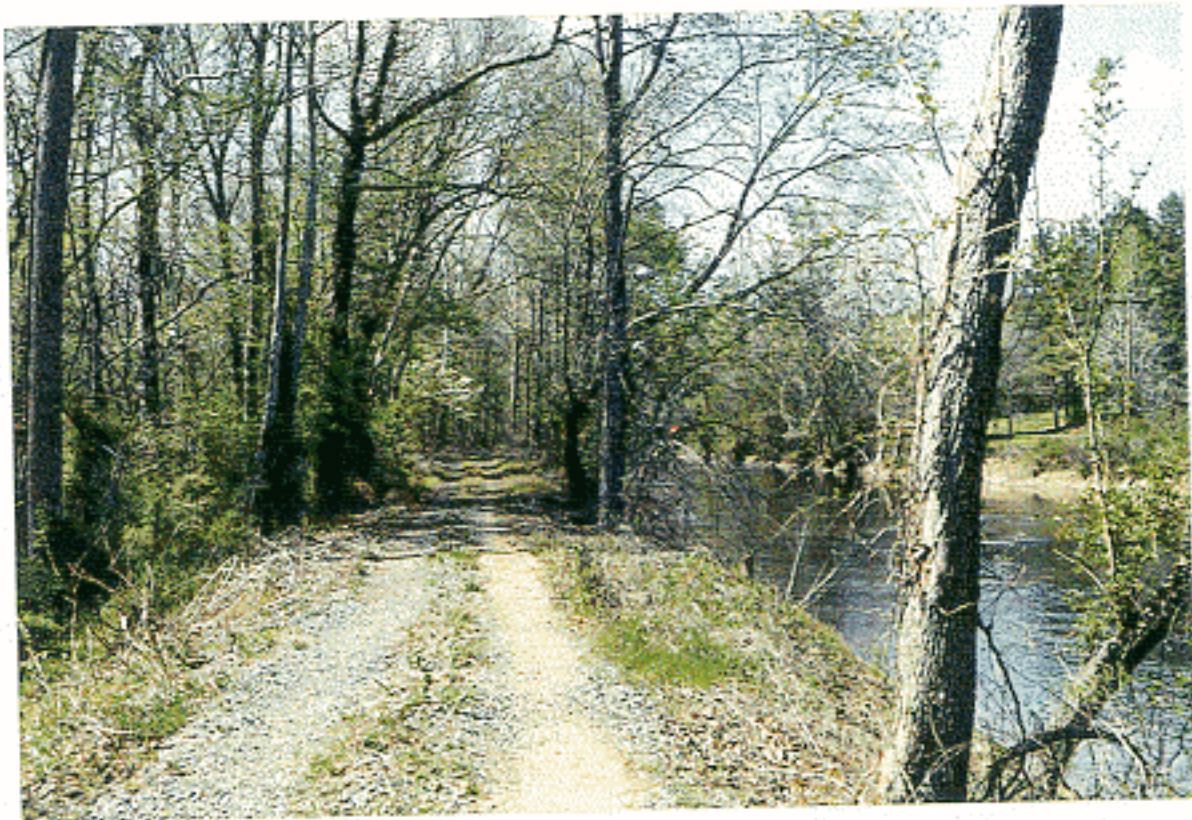
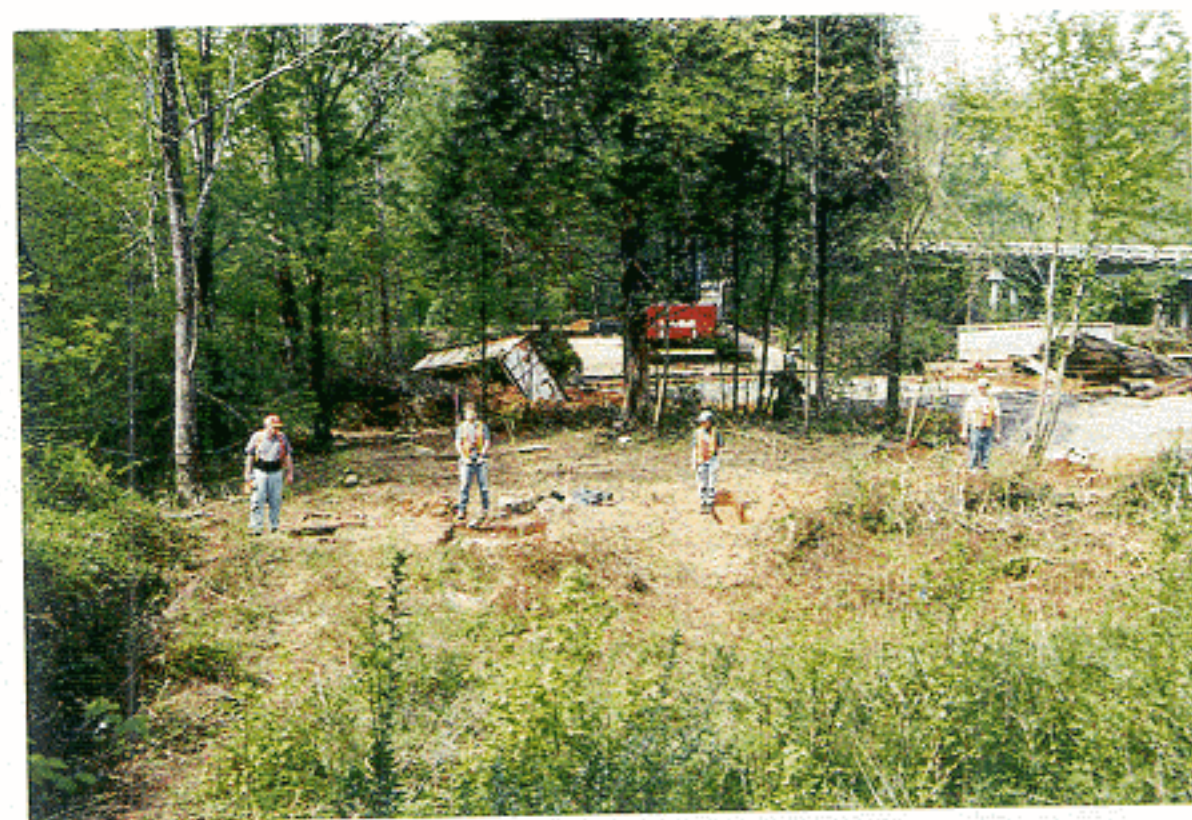
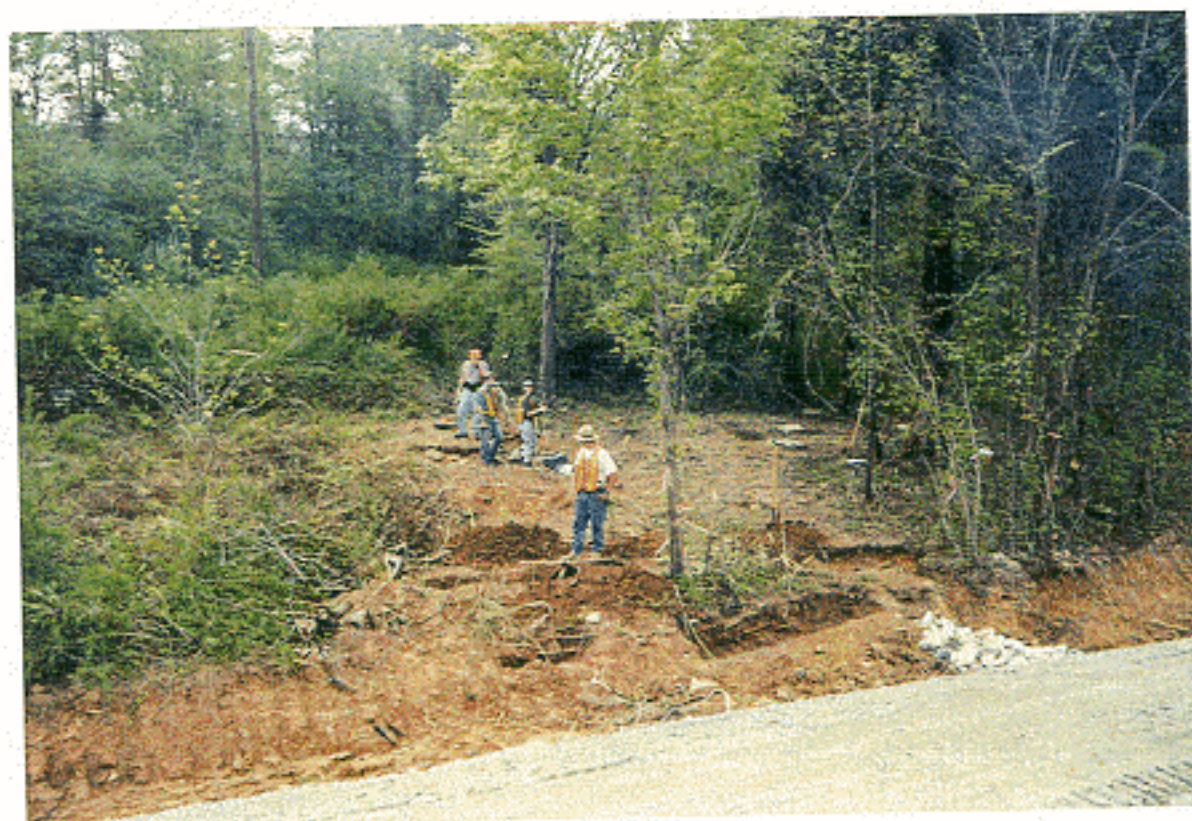
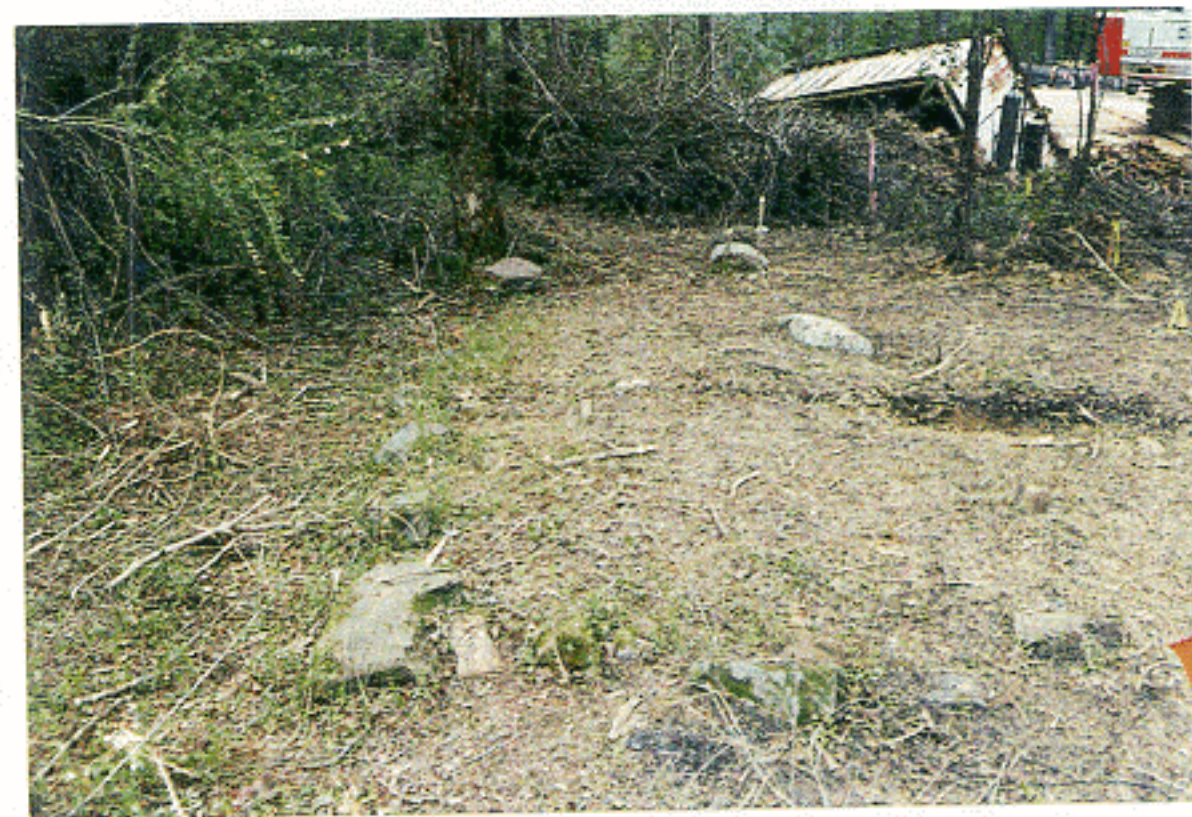
Figure 25. General Views of (a) Canal Towpath and Store Mound Area Next to Lower Terrace, (b) facing south, archaeologists are standing along line of buried stone pier footings, canal in background; (c) facing southeast; (d) close-up of rectangular stone feature on east side of

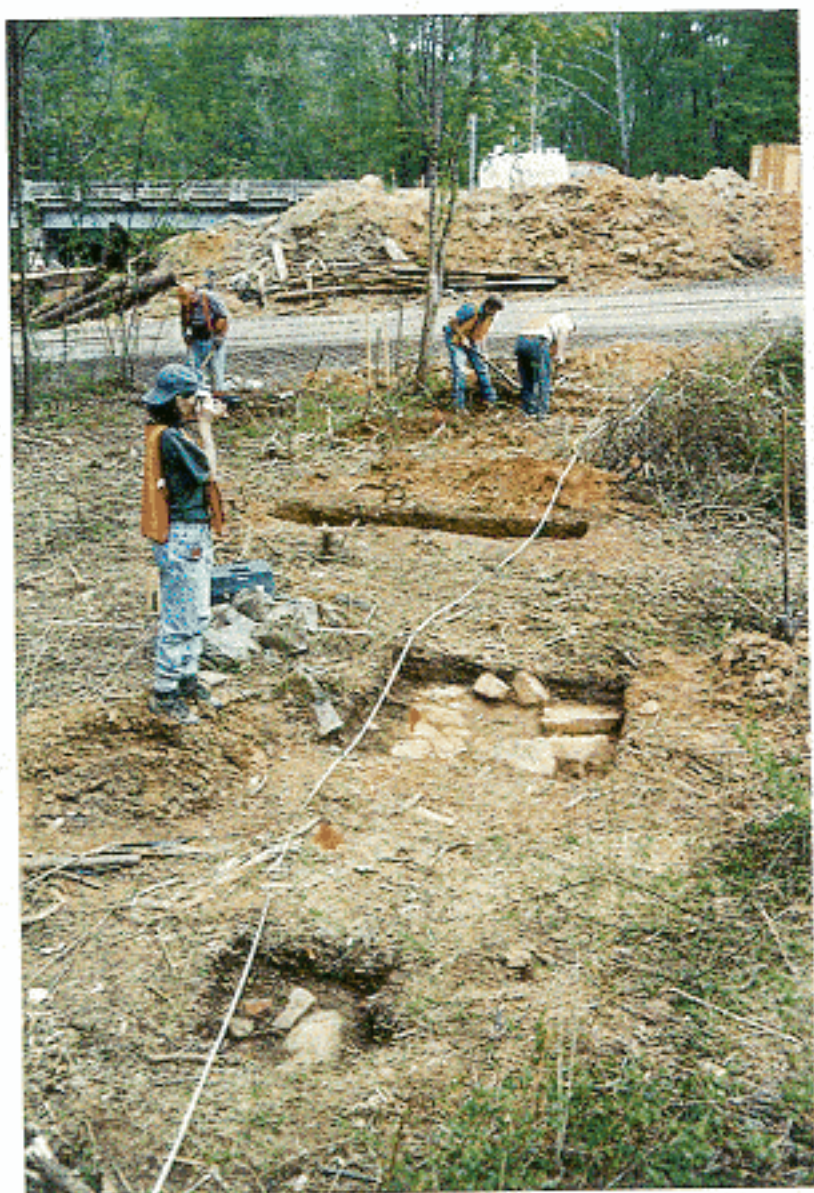
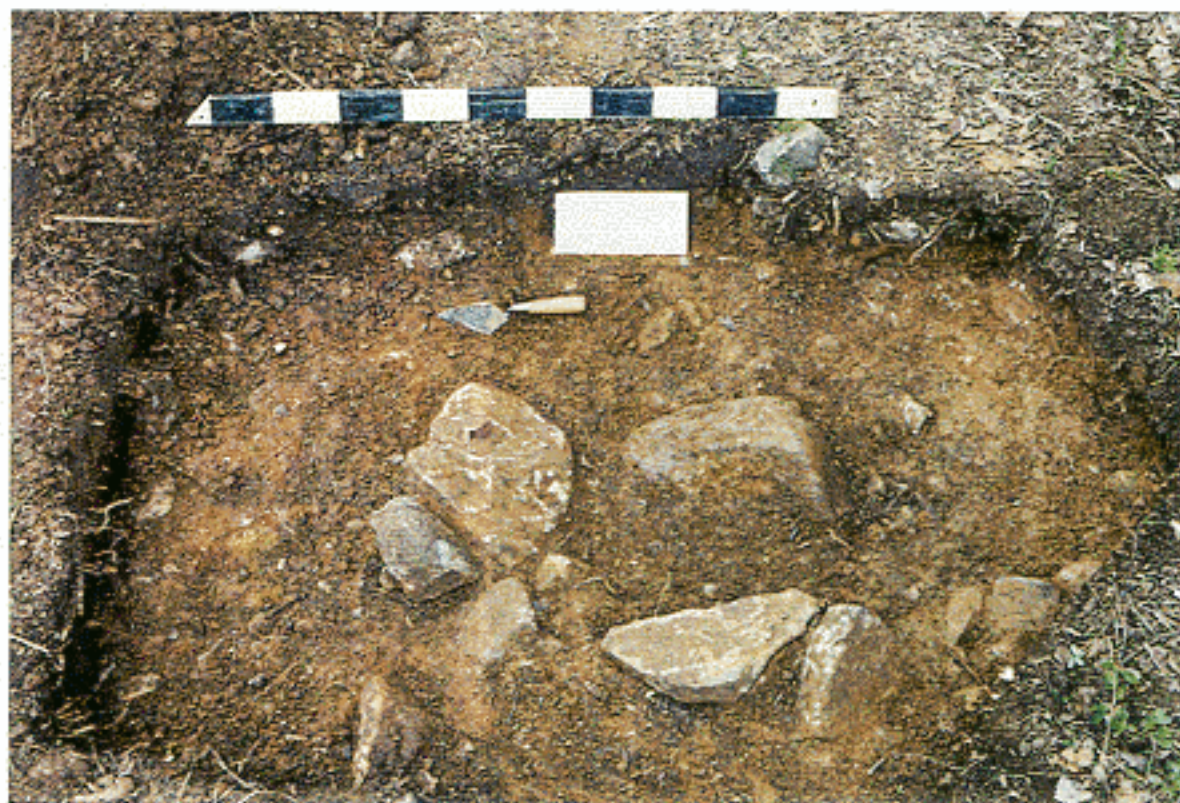
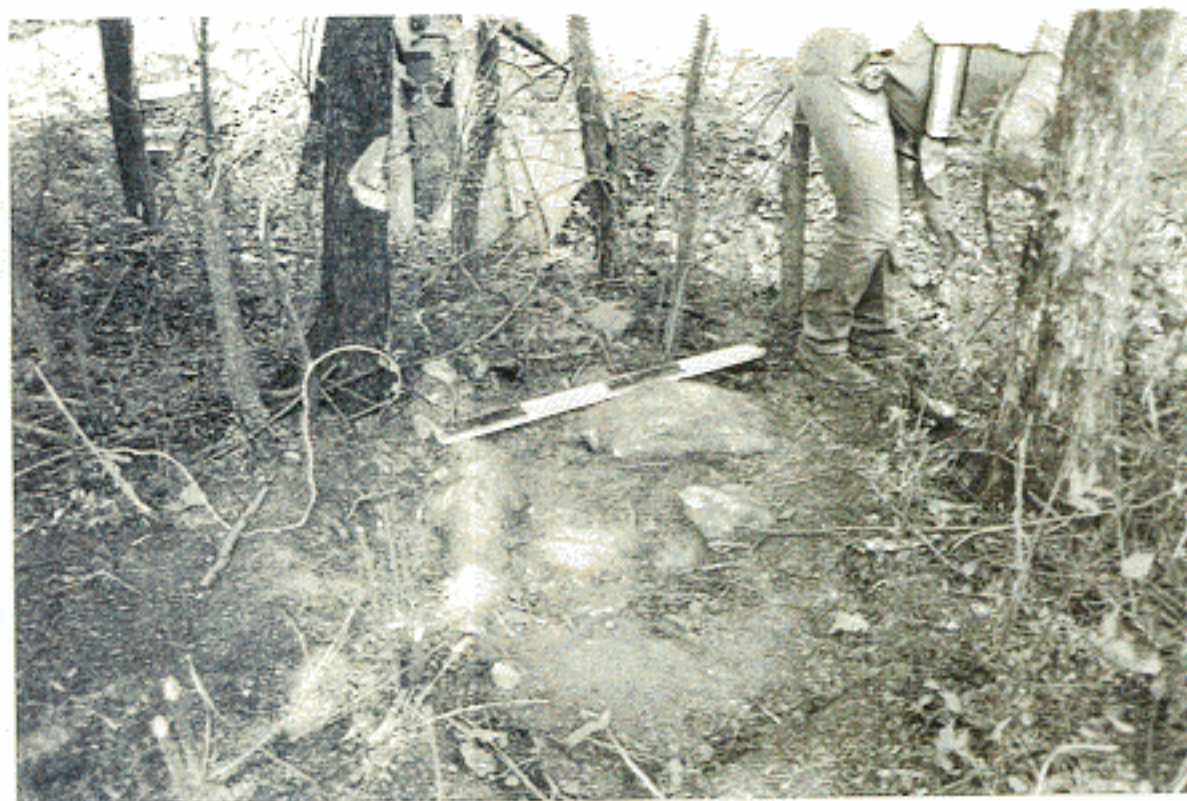
Figure 26. Exposed Foundation Stones in Store Mound Area. (a) From Foreground, Facing West, Excavation Units 1, 2, 3, and 5; (b) Unit 8; (c) Unit 9.

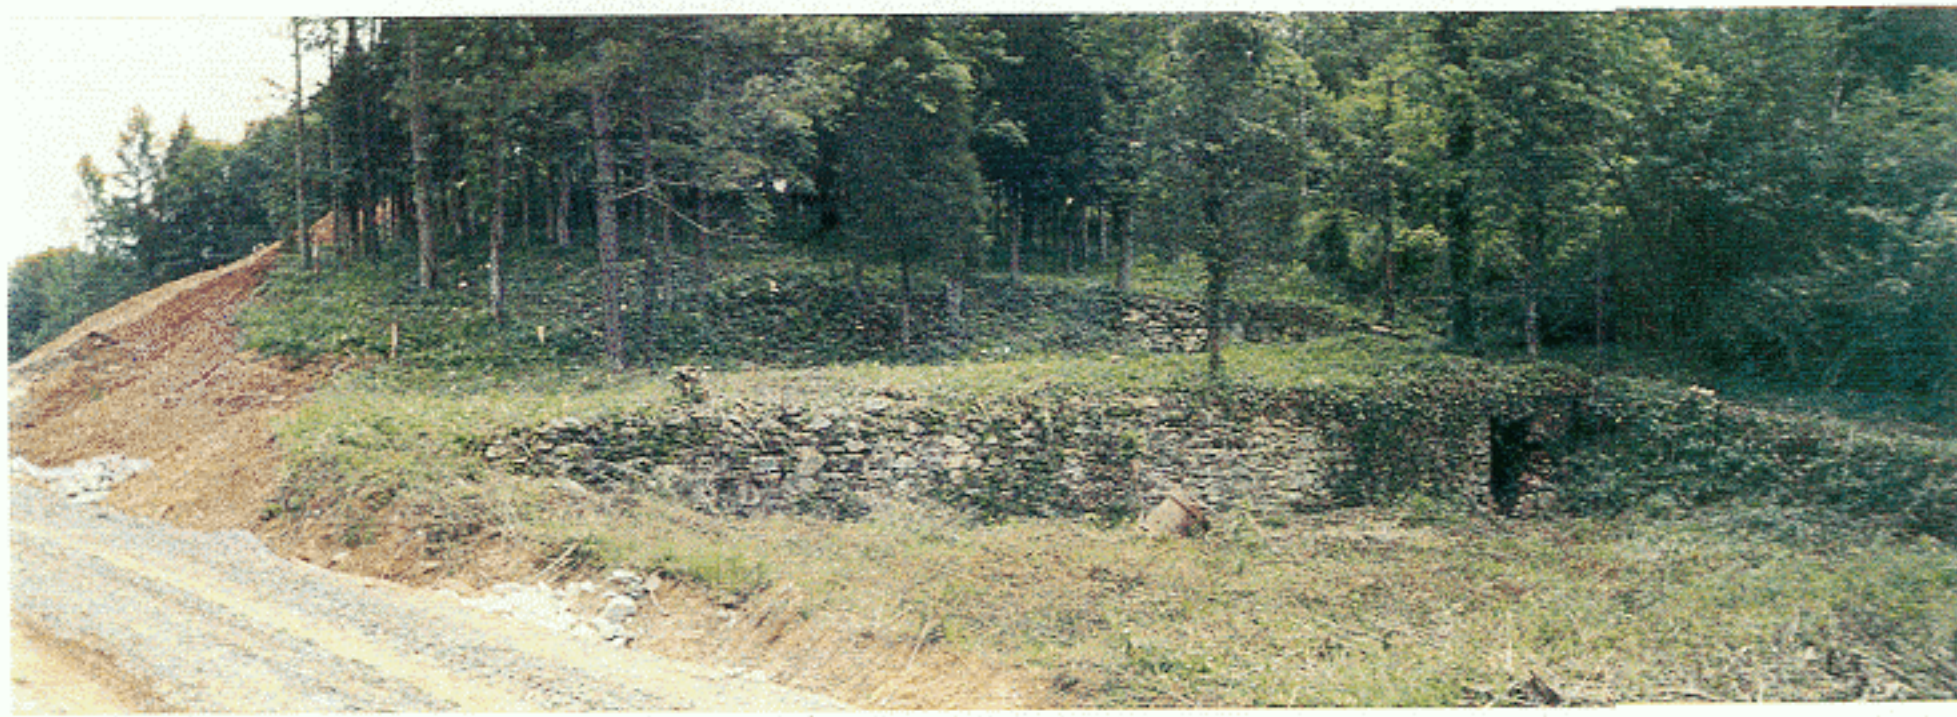
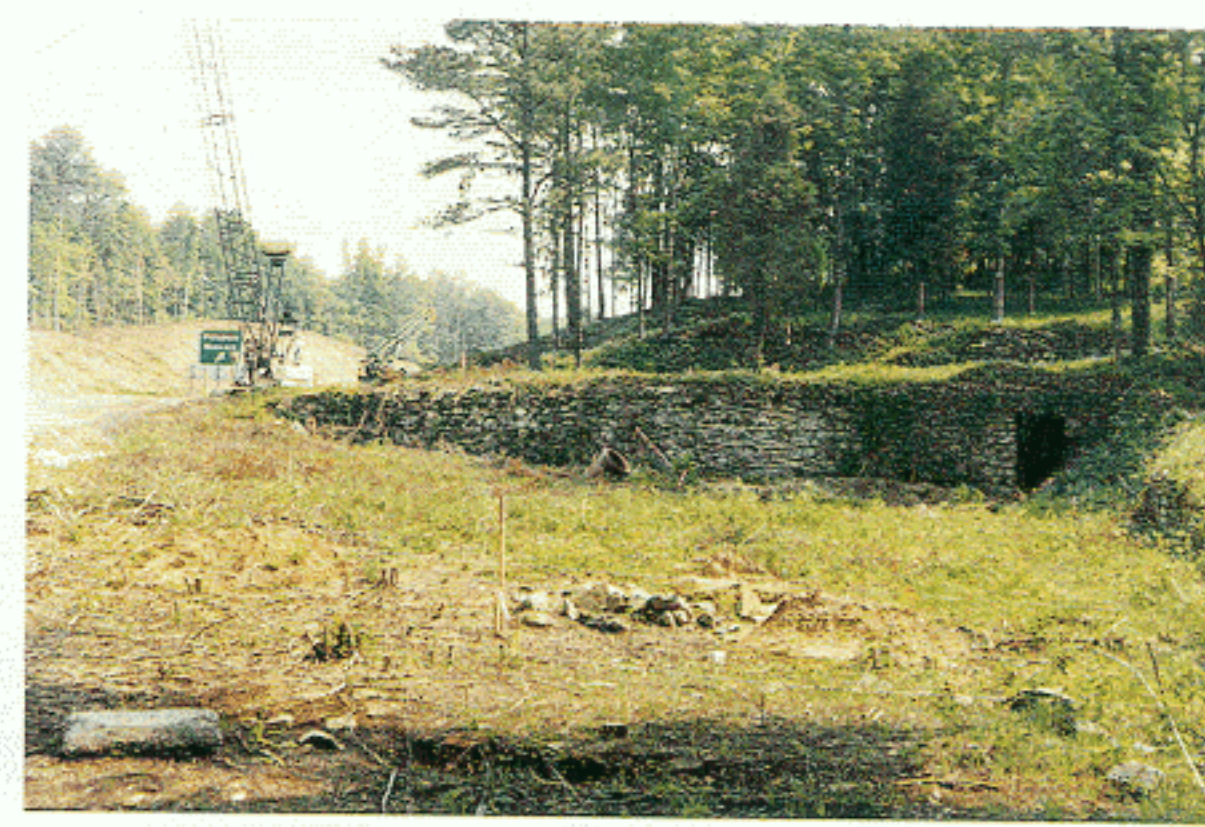
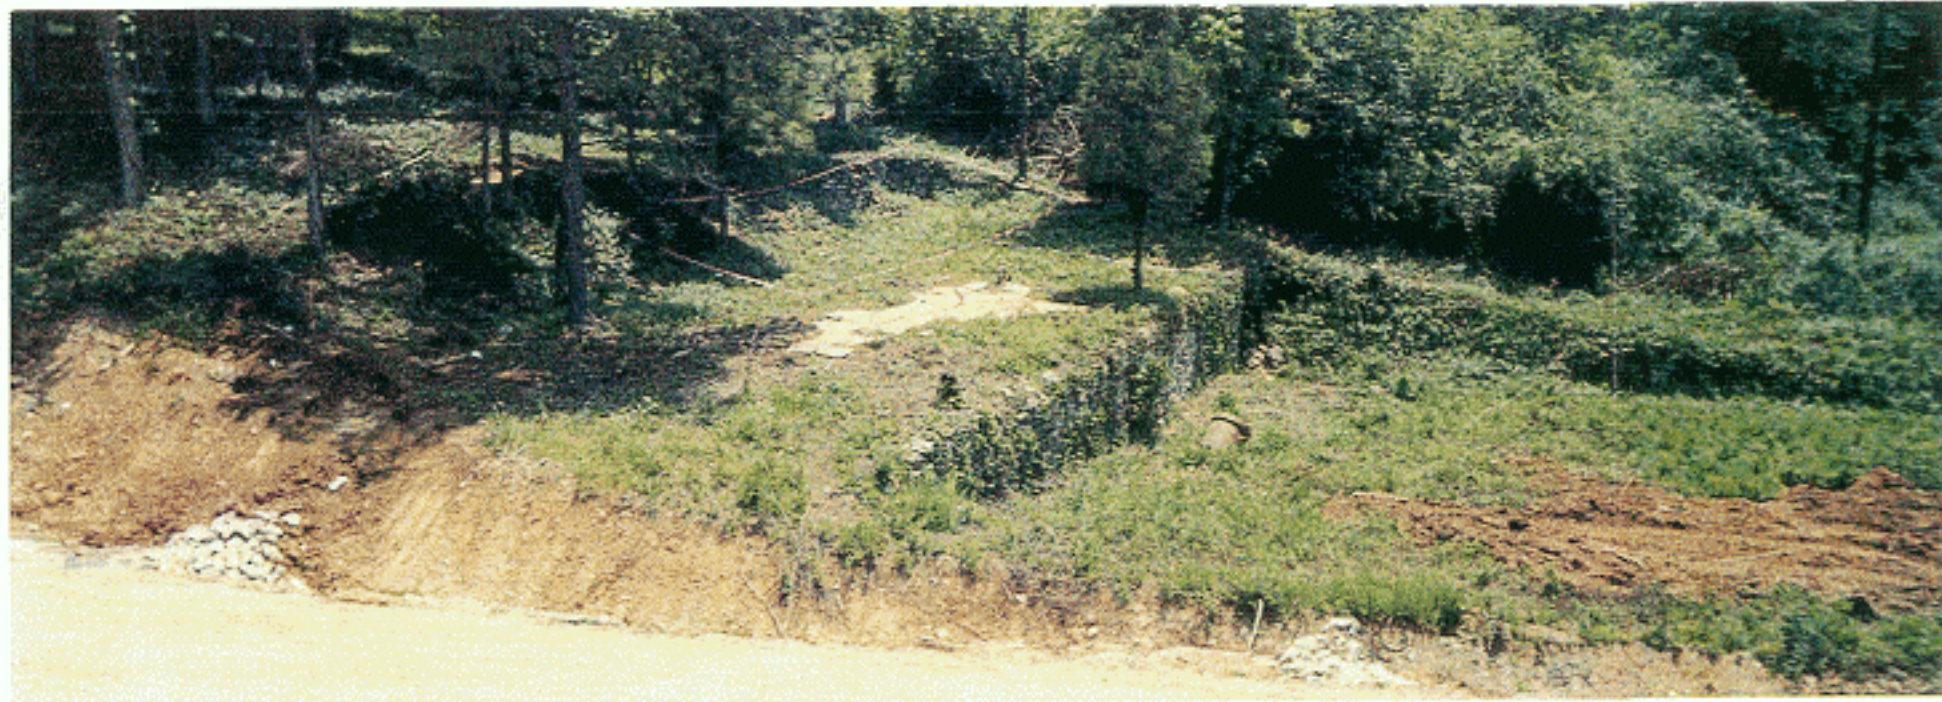
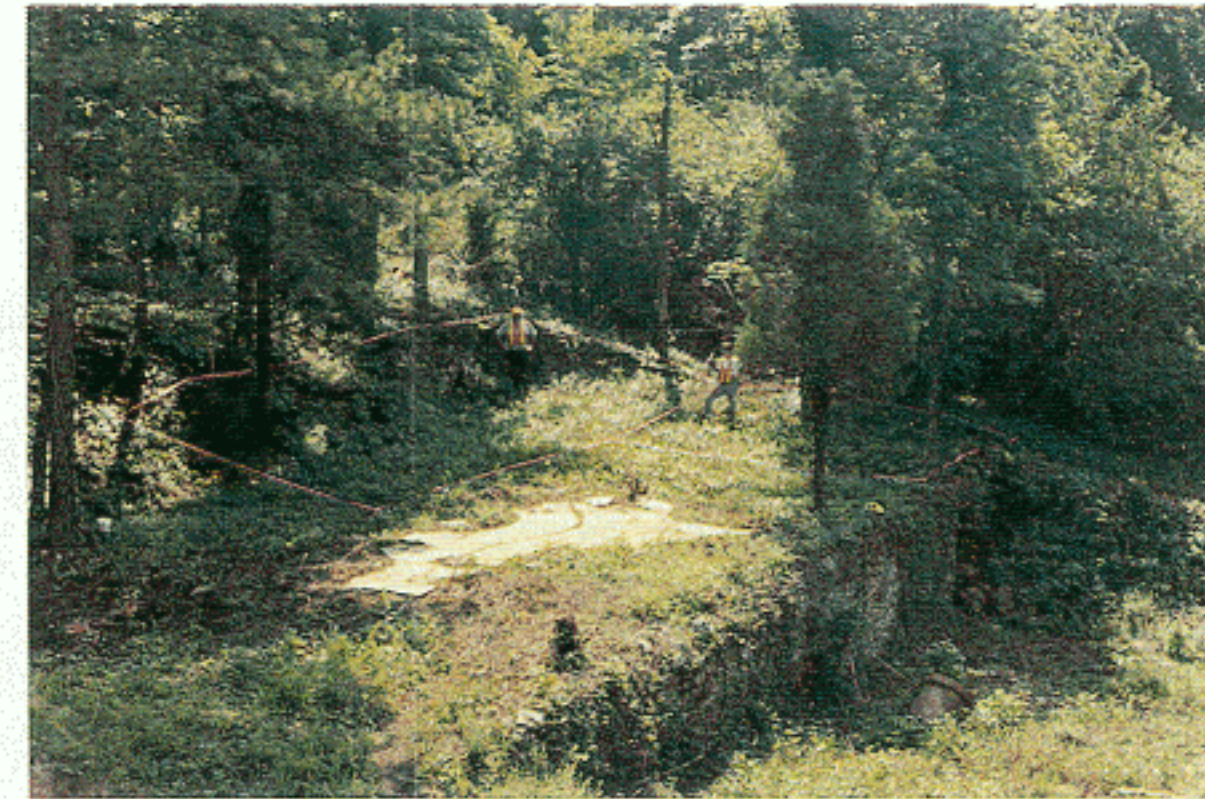
Figure 28. General Views of Archaeological Study Area Showing Major Walls and Terraces. (a) Lower Terrace, Wall 1, First Terrace and Wall 2 (facing northeast); (b) Store Mound, Lower Terrace and Wall 1 (facing north); (c) Lower Terrace on right, First Terrace with Drive on left; (d) Close-up of First Terrace with Concrete Drive; (c, d) ribbon marks former location of Barringer House.
